## C6-FLX Preliminary Occurrence Report

| Location | Occurrence Number |
|---|---|
| Near San Andros Airport<br>(MYAN), San Andros, Andros,<br>Bahamas | OCC-2026-0023 |
| 10 <sup>th</sup> July, 2026<br>12:48 pm EDT <sup>1</sup> (1648 UTC <sup>2</sup> ) | C6-FLX |
| Cessna 402C | 402C0628 |

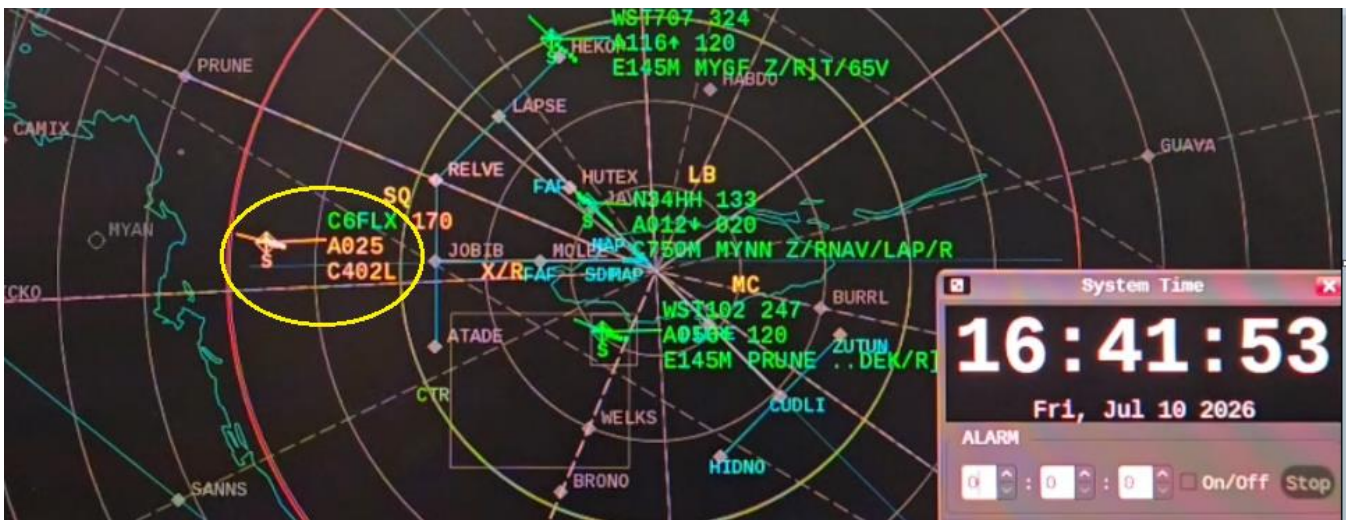
The flight was uneventful upon departure as radar footage from Nassau Approach Control showed C6-FLX flew westbound enroute to MYAN, cancelling its air traffic services at approximately ten (10) nautical miles east of MYAN at 12:41 pm EDT (1641 UTC).

*Fig. 1: Radar imagery of C6-FLX position after cancellation of VFR flight plan with Nassau Approach Control*

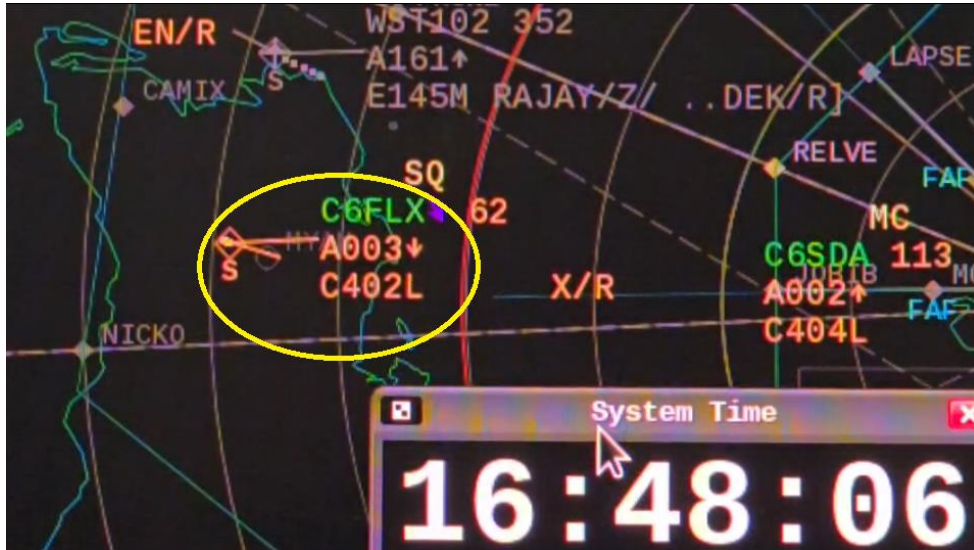
At this point, according to radar data, the aircraft was descending out of approximately 1,800 feet on its approach to land at MYAN. During the final data recorded by radar, C6-FLX showed an altitude of approximately 300 feet at an indicated airspeed of 62 knots at approximately 12:48 pm EDT (1648 UTC).

*Fig. 2: Radar imagery of C6-FLX last radar position via Nassau Approach Control*

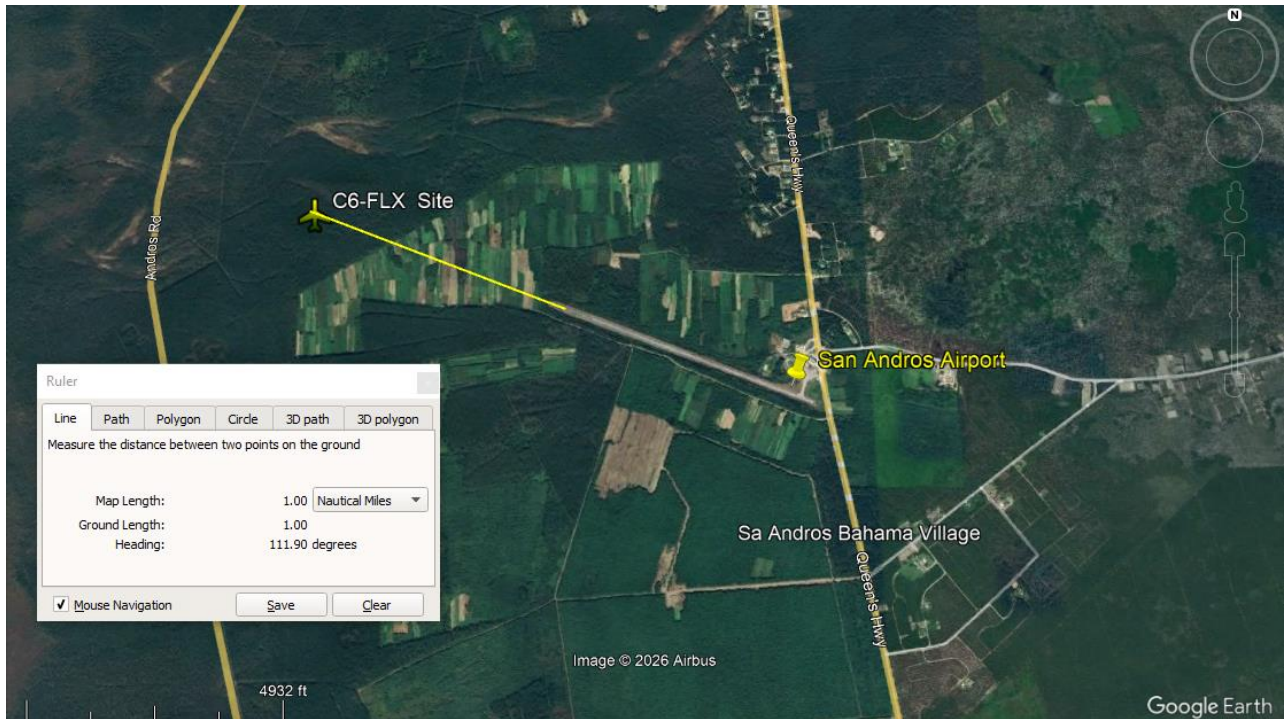
As the forward motion of the aircraft carried it into the path of tall pine trees, the trajectory of the aircraft shifted from its aligned path with runway 12 at MYAN to the aircraft wreckage ultimately coming to rest flatly facing a magnetic heading of approximately 185° at coordinates 25° 3'42.59"N 78° 4'27.24"W at a distance of approximately one (1) nautical mile from MYAN. Following the impact, the aircraft was consumed and destroyed by post-impact fire.

**Fig.3: Google earth imagery of C6-FLX crash site in relation to MYAN**

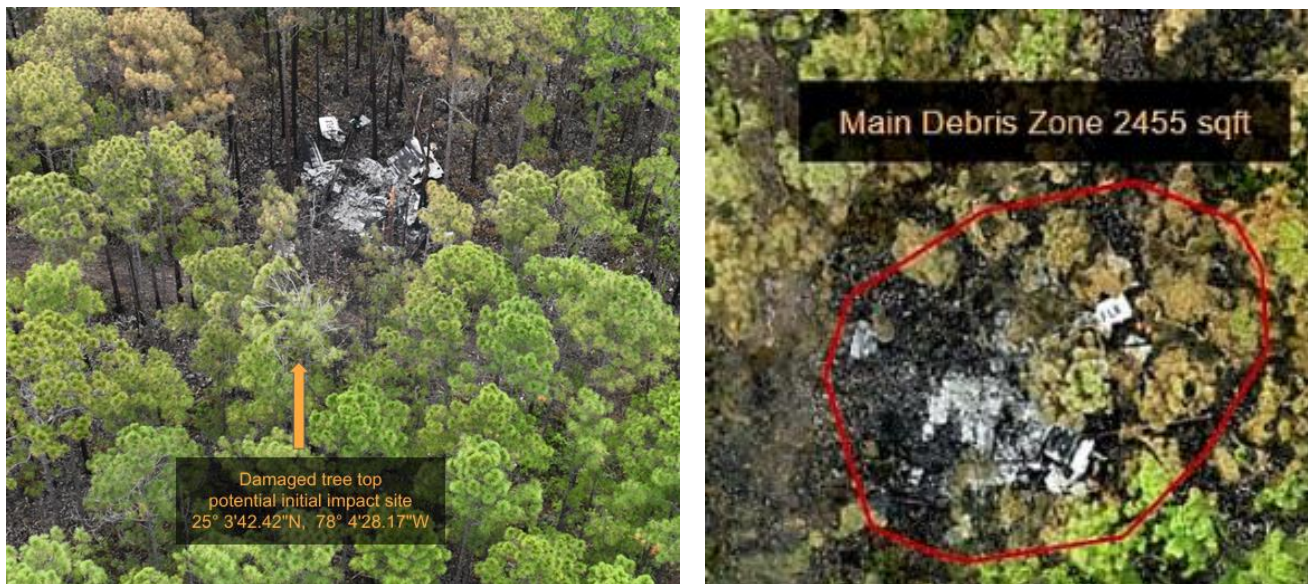
Aerial drone photos suggest that the possible initial point of aircraft impact with the top of trees were at coordinates 25° 3'42.42"N 78° 4'28.17"W. From this initial point of contact with trees, the aircraft forward motion continued as it made further contact at the mid and lower levels of a stand of pine trees.

Subsequently, the aircraft shifted from its path of alignment with runway 12 at MYAN to ultimately coming to rest oriented facing a magnetic heading of approximately 185°. Preliminary observations of fire signature markings on the aircraft wreckage suggests that a post-crash fire ensued. The main debris zone was confined to an area of approximately 2,455 square feet. There were several fell trees within the main debris zone with a few of them observed to be laying perpendicular to and on top of the aircraft wreckage.

Within the main debris zone, evidence of fire and associated damage to the environment were noted by the charred barks of tree trunks as well as the observed brown colored foliage on the tops of trees. The outer debris zone extended to cover an area of approximately 15,500 square feet in which the furthest piece of aircraft debris (left wing navigation light) was observed at a distance of approximately 85 feet from the main wreckage.

Fig. 6: (Left) drone view of aircraft initial point of contact; (Right) drone view of main debris zone

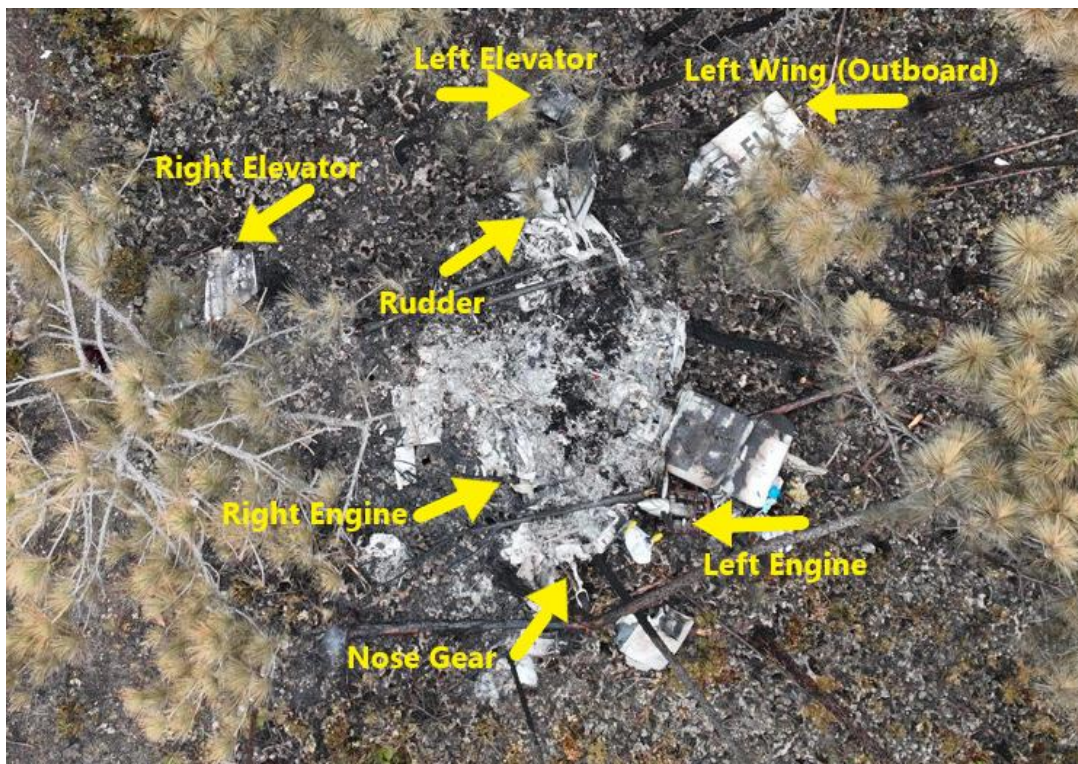
Based on the distribution of the wreckage, it would appear that a low velocity, low angle impact would have occurred.

The fire that ensued destroyed the fuselage of the aircraft. The left engine was damaged by a combination of fire and impact forces. The left propeller was observed still attached to the propeller hub with minimal signs of impact damage to the three (3) propeller blades.

The right engine was extensively damaged by a combination of fire and impact forces. The right propeller remained attached to the propeller hub with substantial signs of impact damage to all three (3) propeller blades. All three (3) propeller blades were observed twisted and bent.

*Fig. 7: Distribution of C6-FLX wreckage at crash site*

The nose and main gear were all observed in the extended position as well as both flaps. This would suggest that the aircraft was configured for landing prior to impact.
